PRELIMINARY DATA REPORT
BRENTON REEF
WELLFLEET
NORWALK
DISPOSAL SITES
AUGUST 1981

CONTRACT #
DACW33-81-C-0115

New England Division
U.S. Army Corps of Engineers
424 Trapelo Rd.
Waltham, MA 02154

The purpose of this report is to document the sampling procedures used during these surveys and to present preliminary results of these measurements.

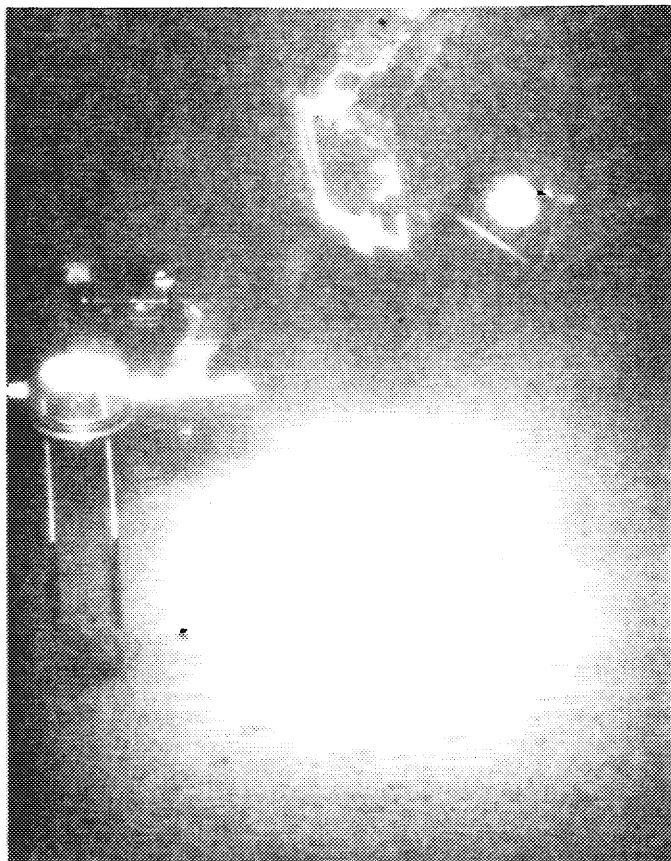
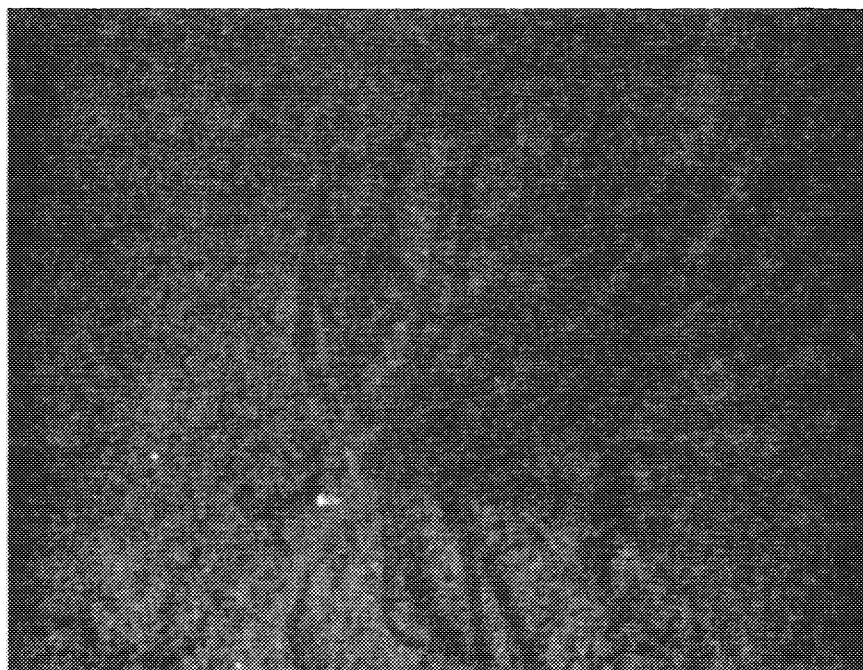
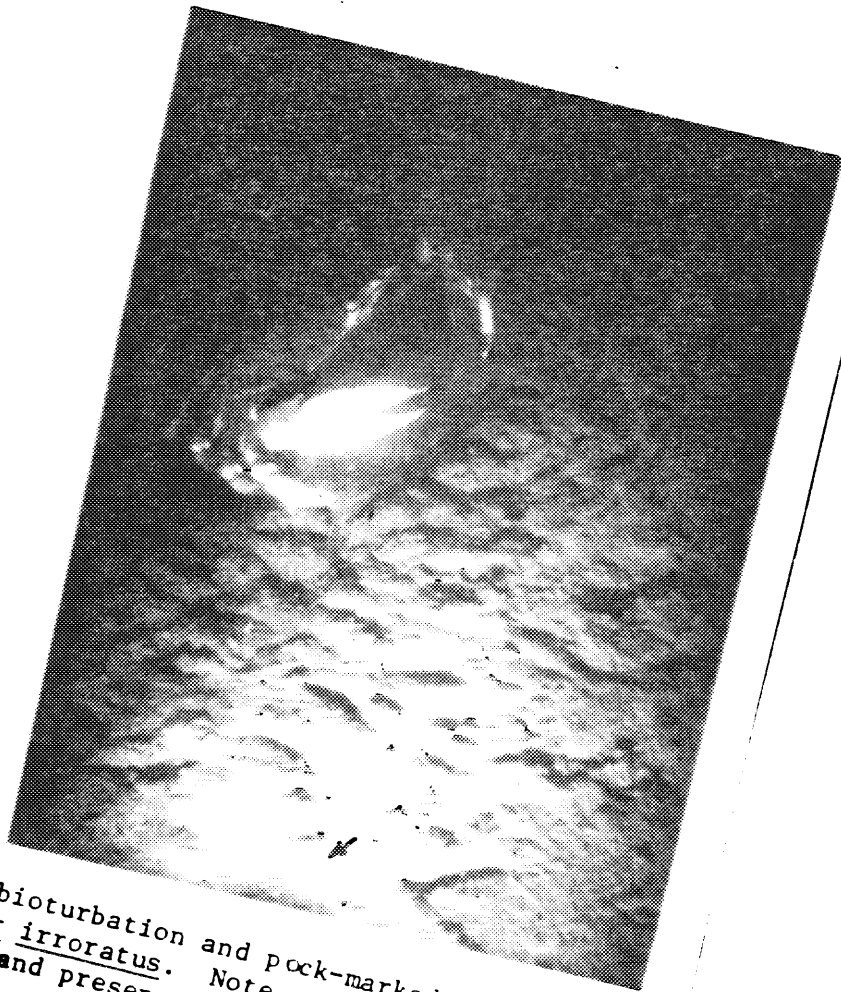
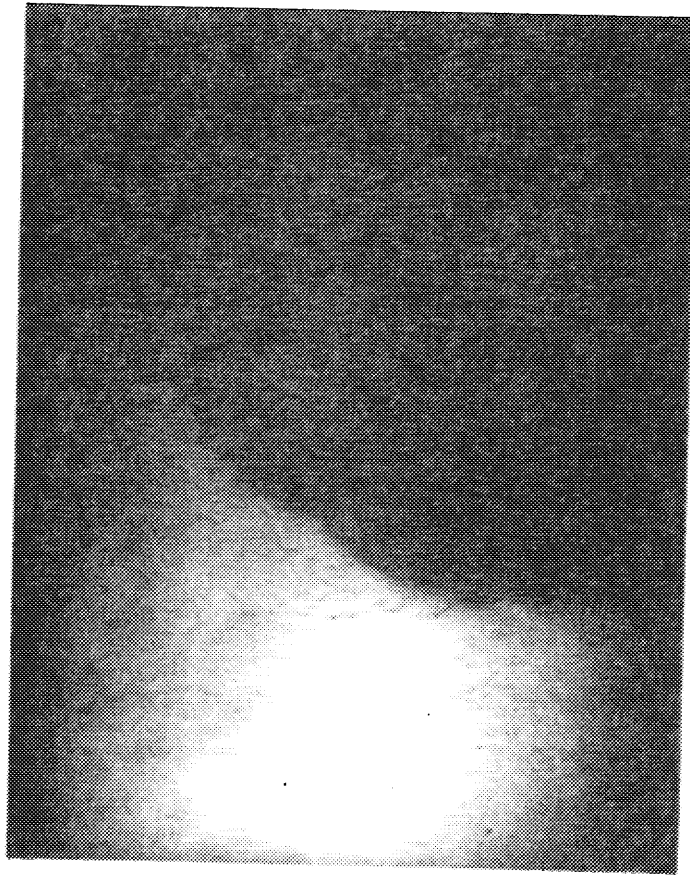
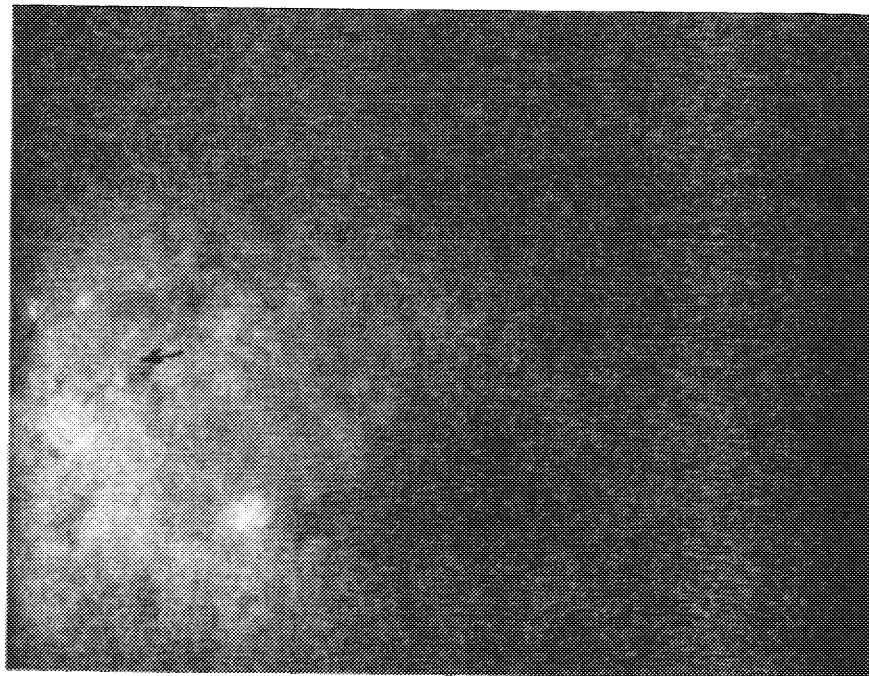
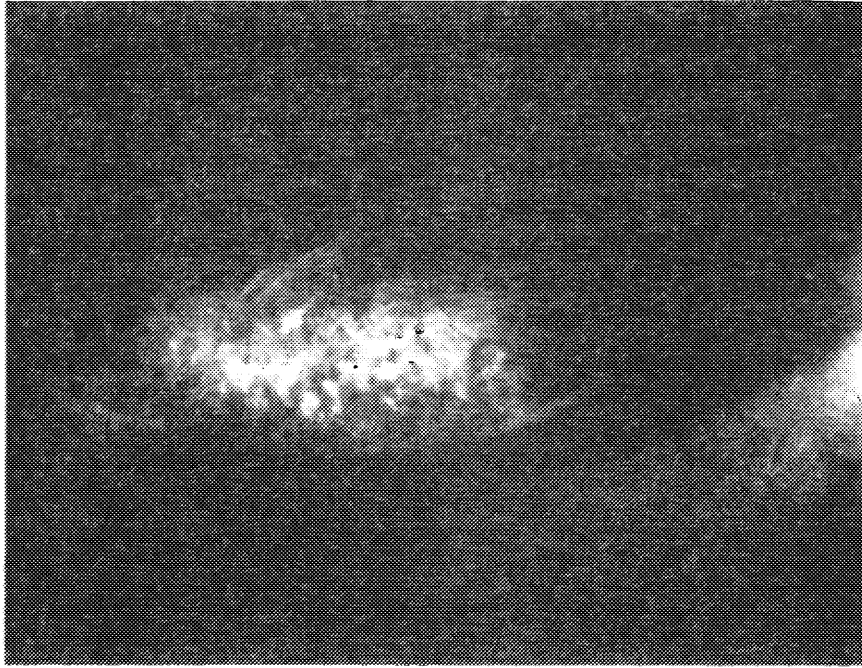
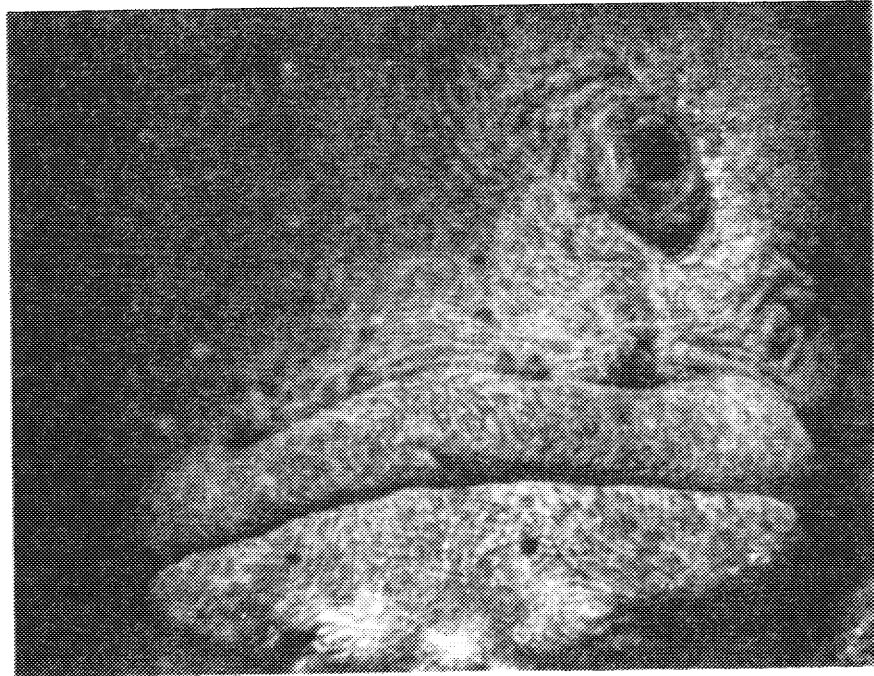
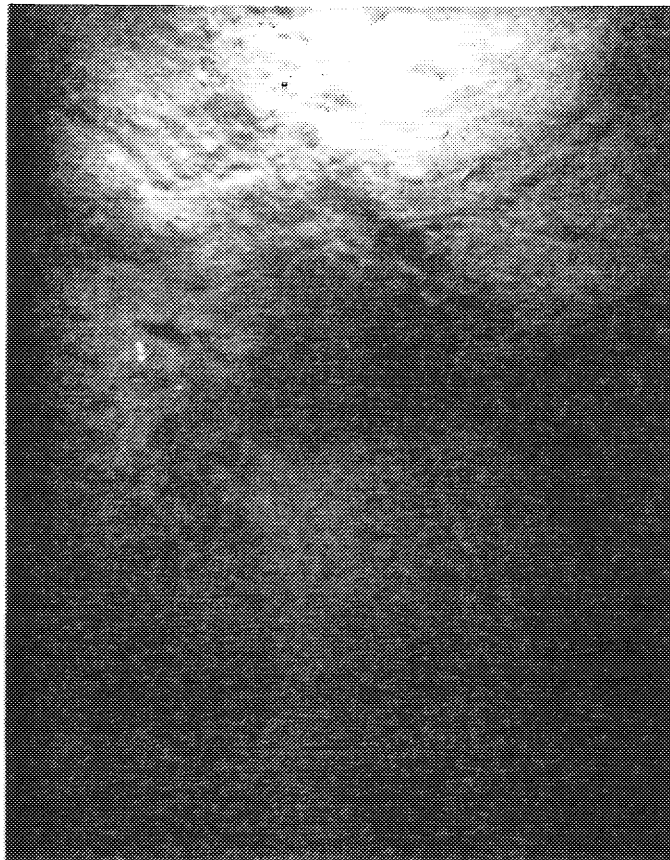
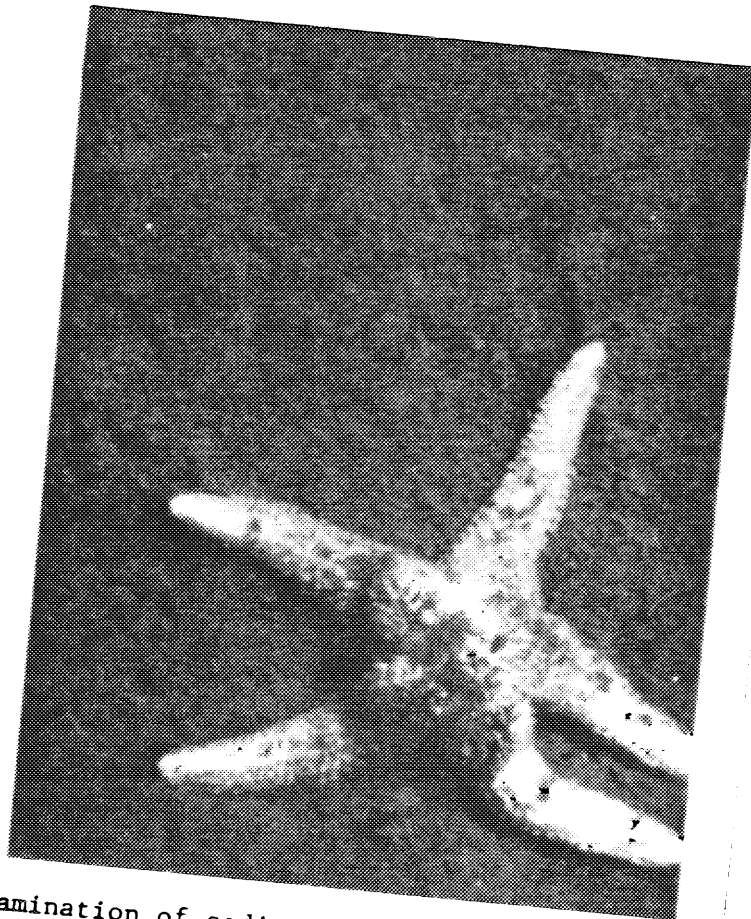
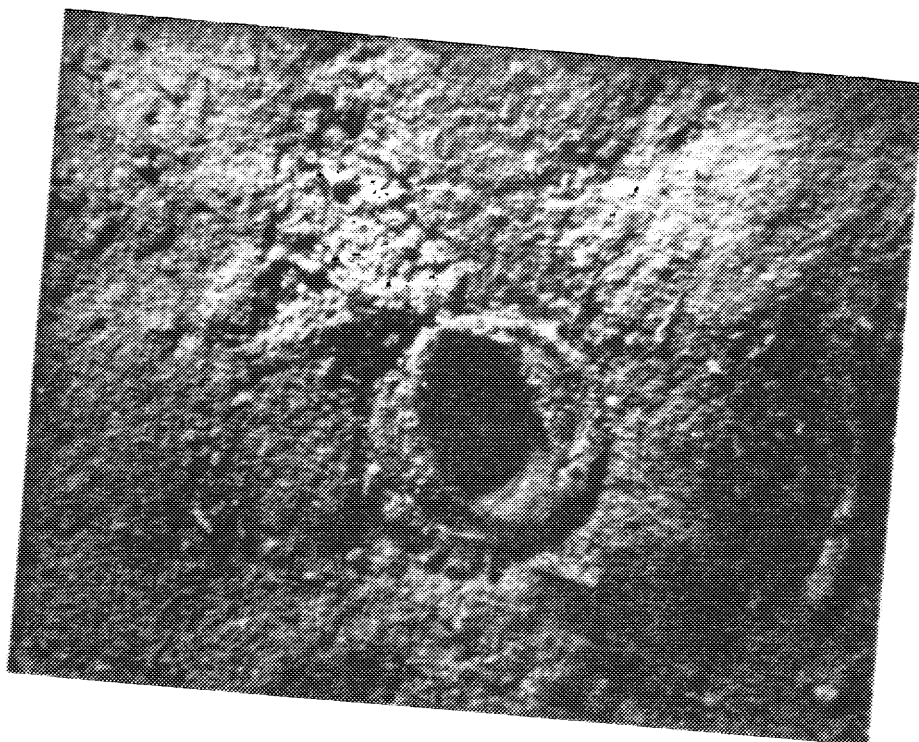
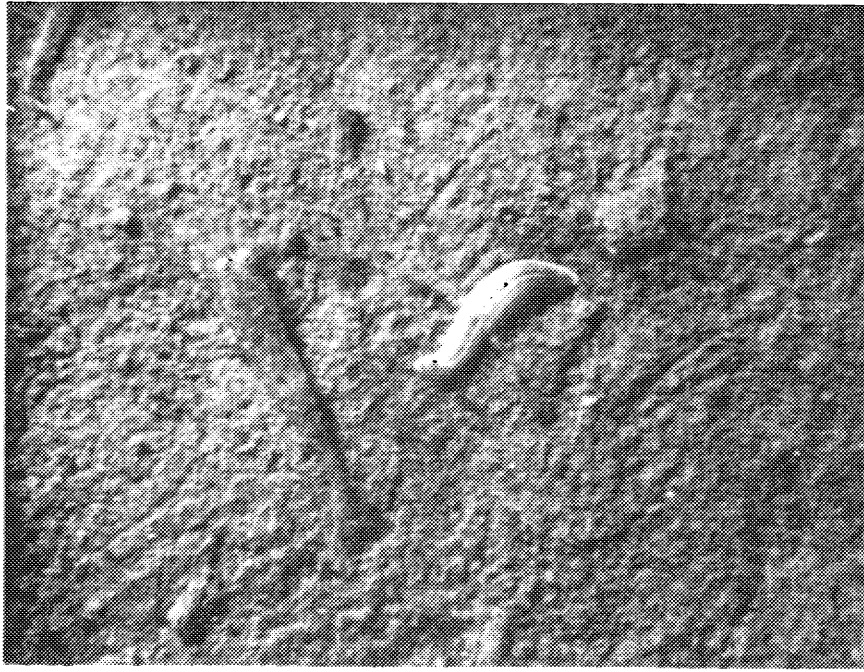
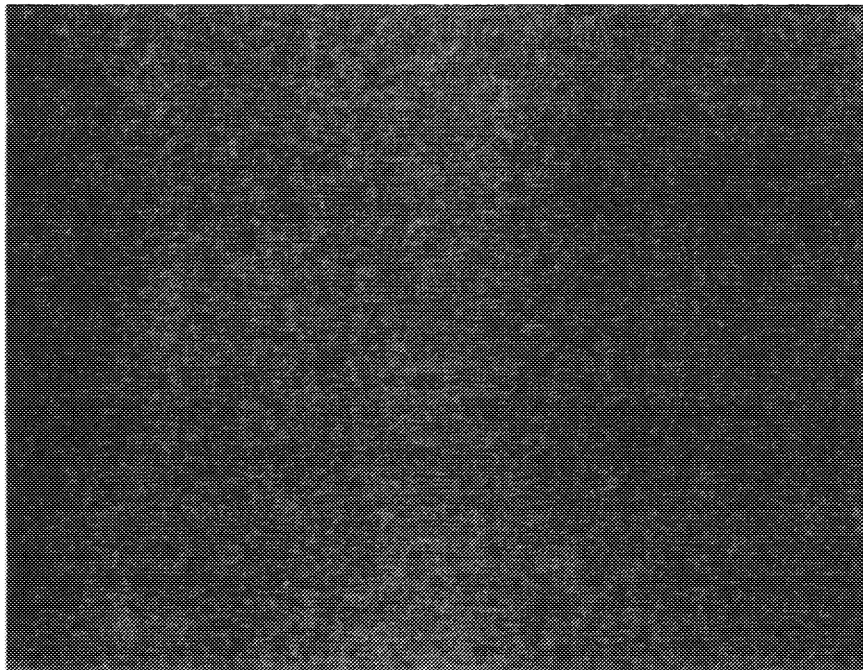
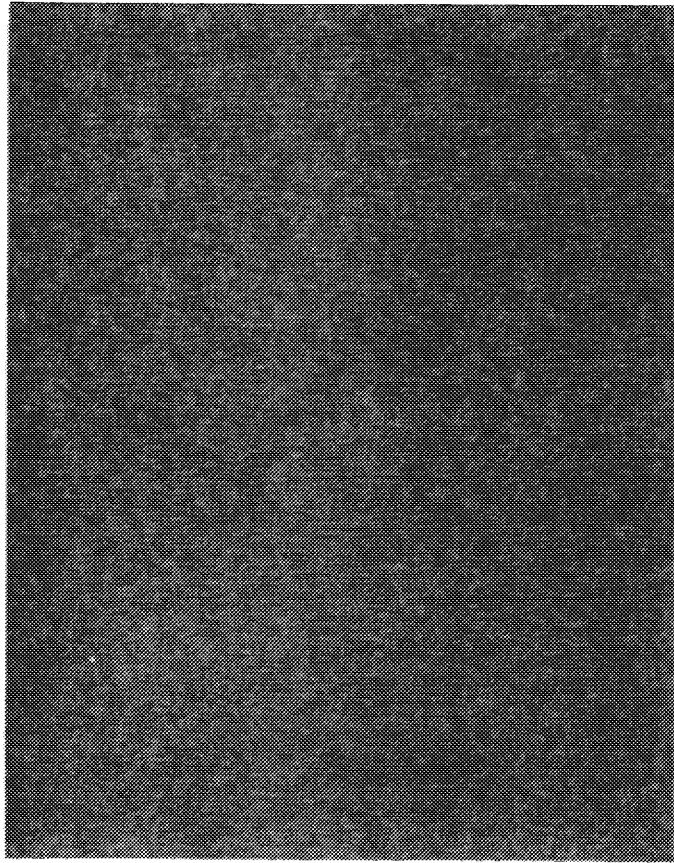
Figure 4.0-6b Surface sediment granular detail surrounding the burrowing anemone Cerianthus americanus.

Figure 4.0-6c Surface bioturbation and pock-marked sediment topography created by Cancer irroratus. Note extensive sediment manipulation (1-2 cm) and presence of flatworm (arrow) on surface.

Artificial excavations (30-40 cm diameter) were often noted on the surface. Spoil material with exposed polychaete worm tubes, shrimp (arrow), motile Asterias, and juvenile fish were often noted around rim.

Figure 4.0-6e Structural features along crest of conical excavation (burrow depressions, small (1 cm diam vertical burrows, mollusk tracks) indicate intense biological activity.

Figure 4.0-6f Burrows of various diameters (20 - 1 cm) indicated, a wide range of species utilized the natural bottom immediately adjacent to new spoil material. Evidence of Corymorpha pendula (arrow) clusters were encountered along the western transect.

Figure 4.0-6g Large hake Urophycis were observed residing in large conical depressions.

Figure 4.0-6h Burrow construction along slope contours was more common with cohesive material maintaining structure shape.

Figure 4.0-6i A juvenile wolf fish Anarhichas was observed within a 1 m mud burrow .

Figure 4.0-6j Clay mound material was less common but equally inhabited by burrow dwelling biota.

Figure 4.0-6k Close examination of sediment surfaces revealed a fecal pellet texture with small spherical sediment balls. (Note Asterias prey posture and isopod in upper left).

Figure 4.0-6l The burrow tube of a retracted Cerianthus with polycheate tubes and Pectinaria cast to right.

Figure 4.0-6m Common epibenthic feeding organisms - Crangon and large (2 cm) platyhelminthes were routinely noted along both transects.

Figure 4.0-6n A mass concentration of amphipods was sighted within a sediment depression zone.

Figure 4.0-60 The solitary stalked hydroid, Corymorpha pendula on finer grained soft mud natural substrate.

In-situ photographs taken during the dive are presented in Figure 4.0-6(a-o).

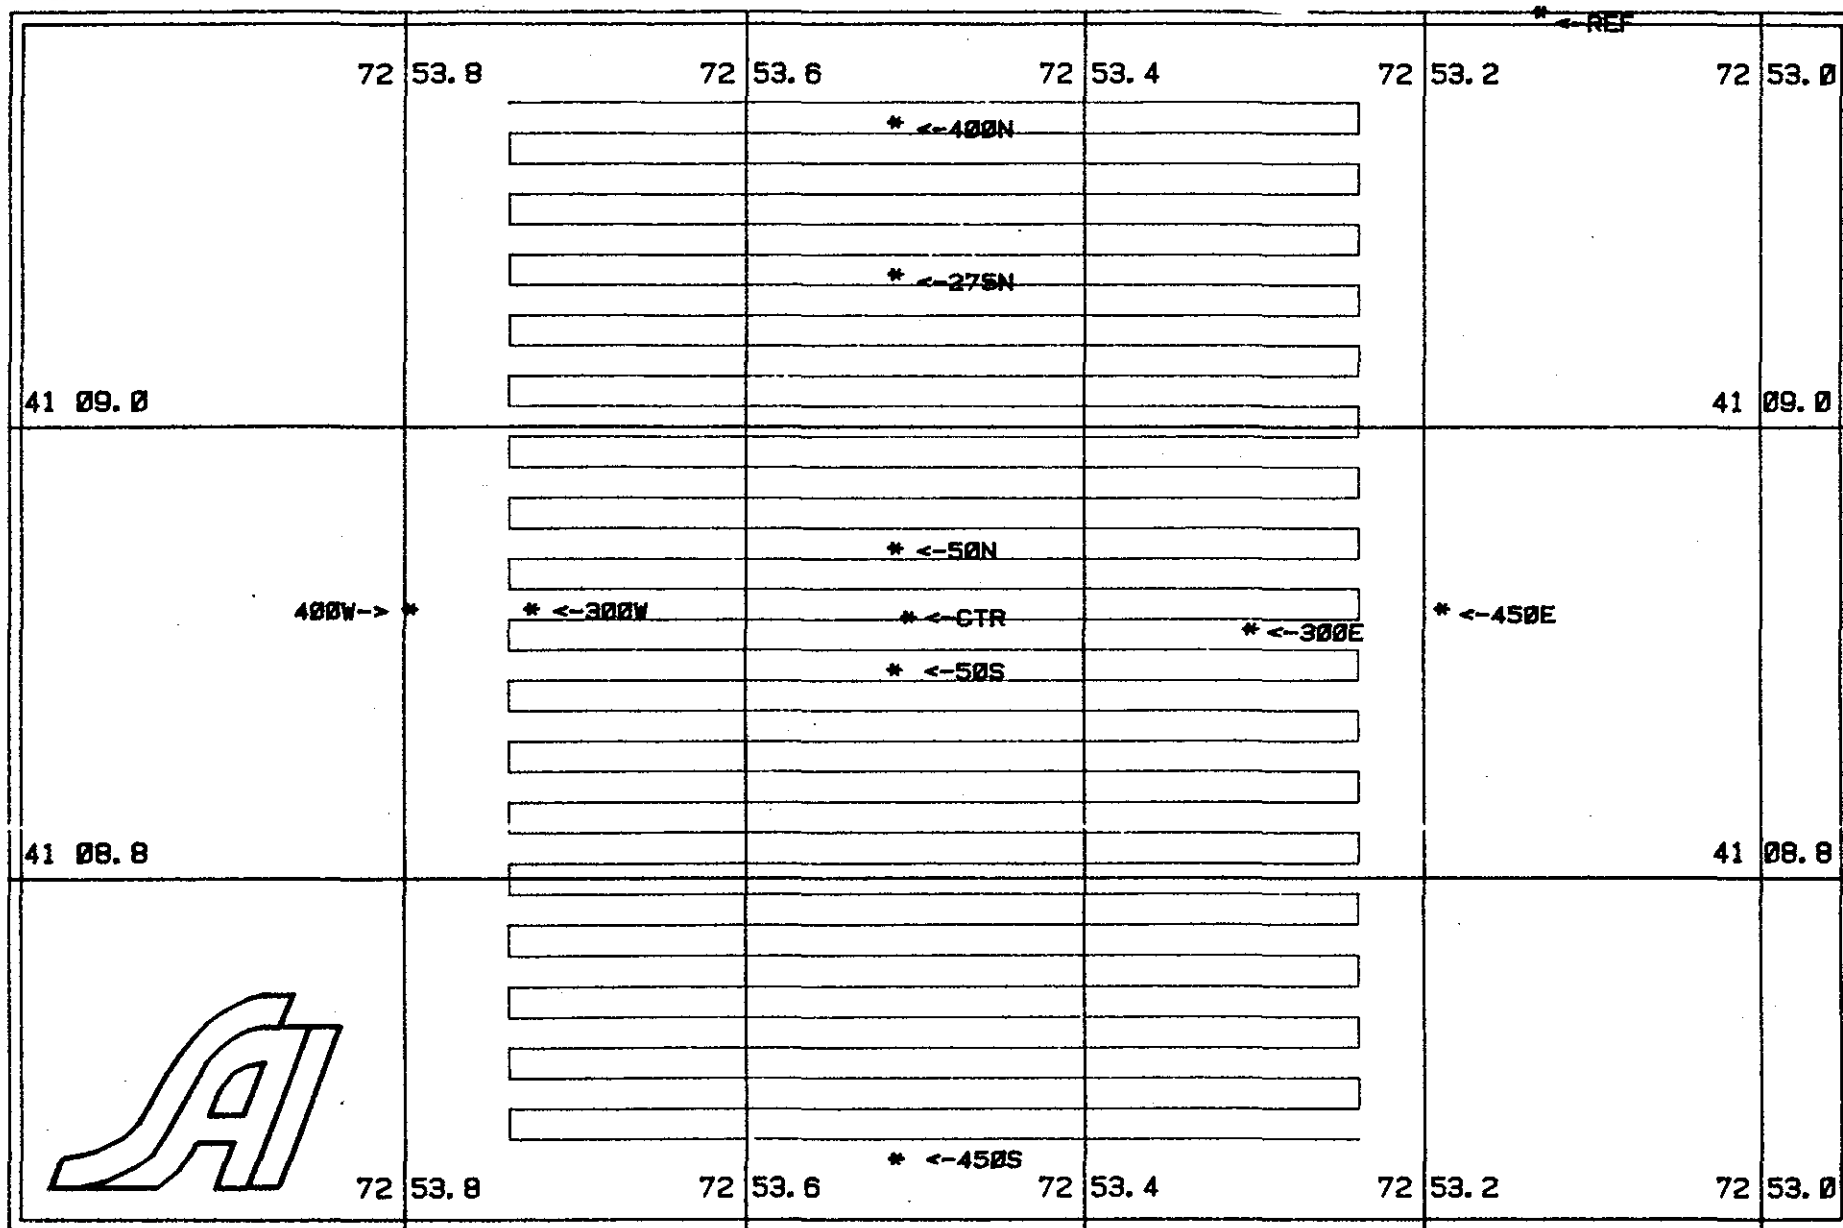
Fig. 5.0-5

Sediment samples were obtained for chemical analysis and benthic identification at the locations shown in Figure 5.0-5 and listed in Table 5.0-1. Ten replicates were taken at each of four biological stations designated as the center of the mound, the inner edge (300 E), the outer edge (450 E) and the reference station. Three replicates were obtained at the remaining chemical stations located at the inner and outer edges in the north, south and west directions.

NORWALK AUG81 SEDIMENT SAMPLES
